SITE INSPECTION OF  
SLOAN LANDFILL  
PREPARED UNDER

TDD NO. F3-8706-13  
EPA NO. PA-595  
CONTRACT NO. 68-01-7346

FOR THE  
HAZARDOUS SITE CONTROL DIVISION  
U.S. ENVIRONMENTAL PROTECTION AGENCY

MARCH 29, 1988

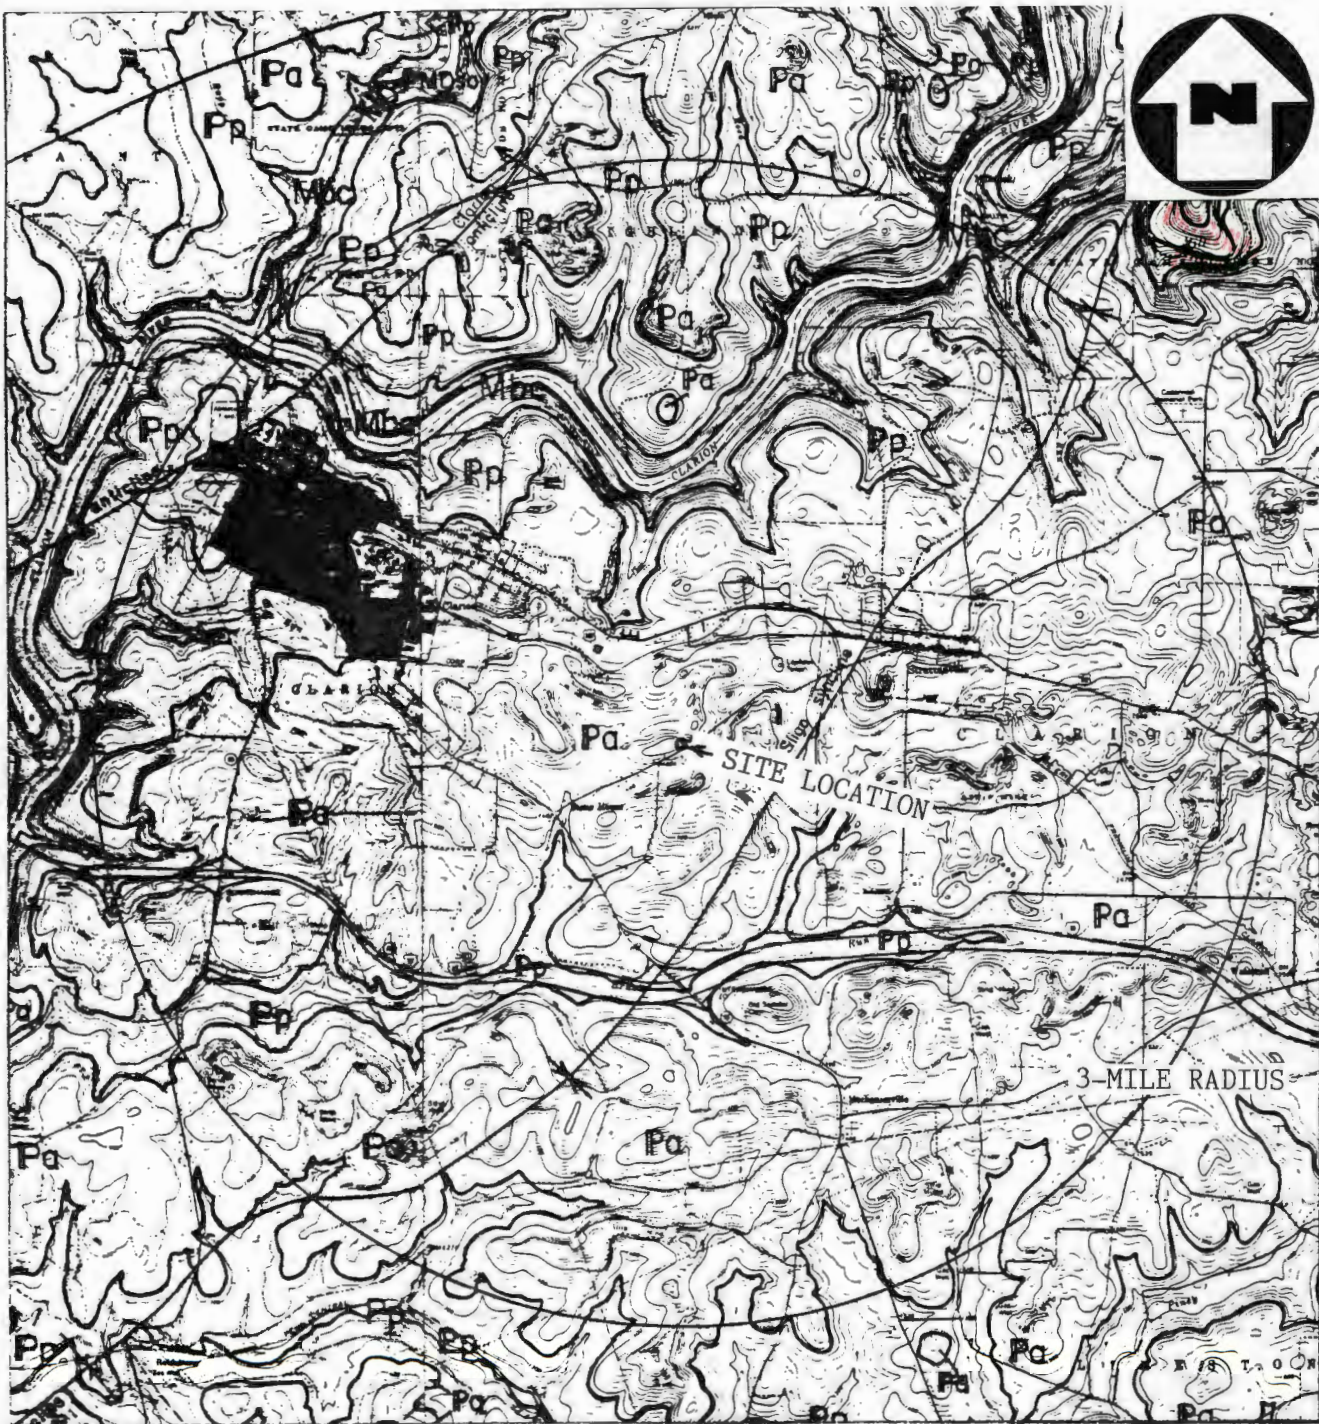
FIGURE 3.1

Bedrock underlying the site is mapped as the Pennsylvanian age Allegheny Group, which contains several economically important coal beds separated by shale, sandstone, limestone, and clay (see figure 3.1, page 3-3). This group includes strata between the top of the Upper Freeport coal and the base of the Brookville coal, with individual units differing in thickness from one area to another. Throughout most of the group, the shales are gray, except in the upper portions where they are greenish-gray. Massive, coarse-grained sandstone are prominent in many areas.<sup>11</sup>

Pa  
Allegheny Gp.  
Pp  
Pottsville Gp.  
Mbc  
Burgoon Sa. through  
Cuyahoga Gp., undiv. } Pocono Group

GEOLOGIC MAP  
SLOAN LANDFILL SITE

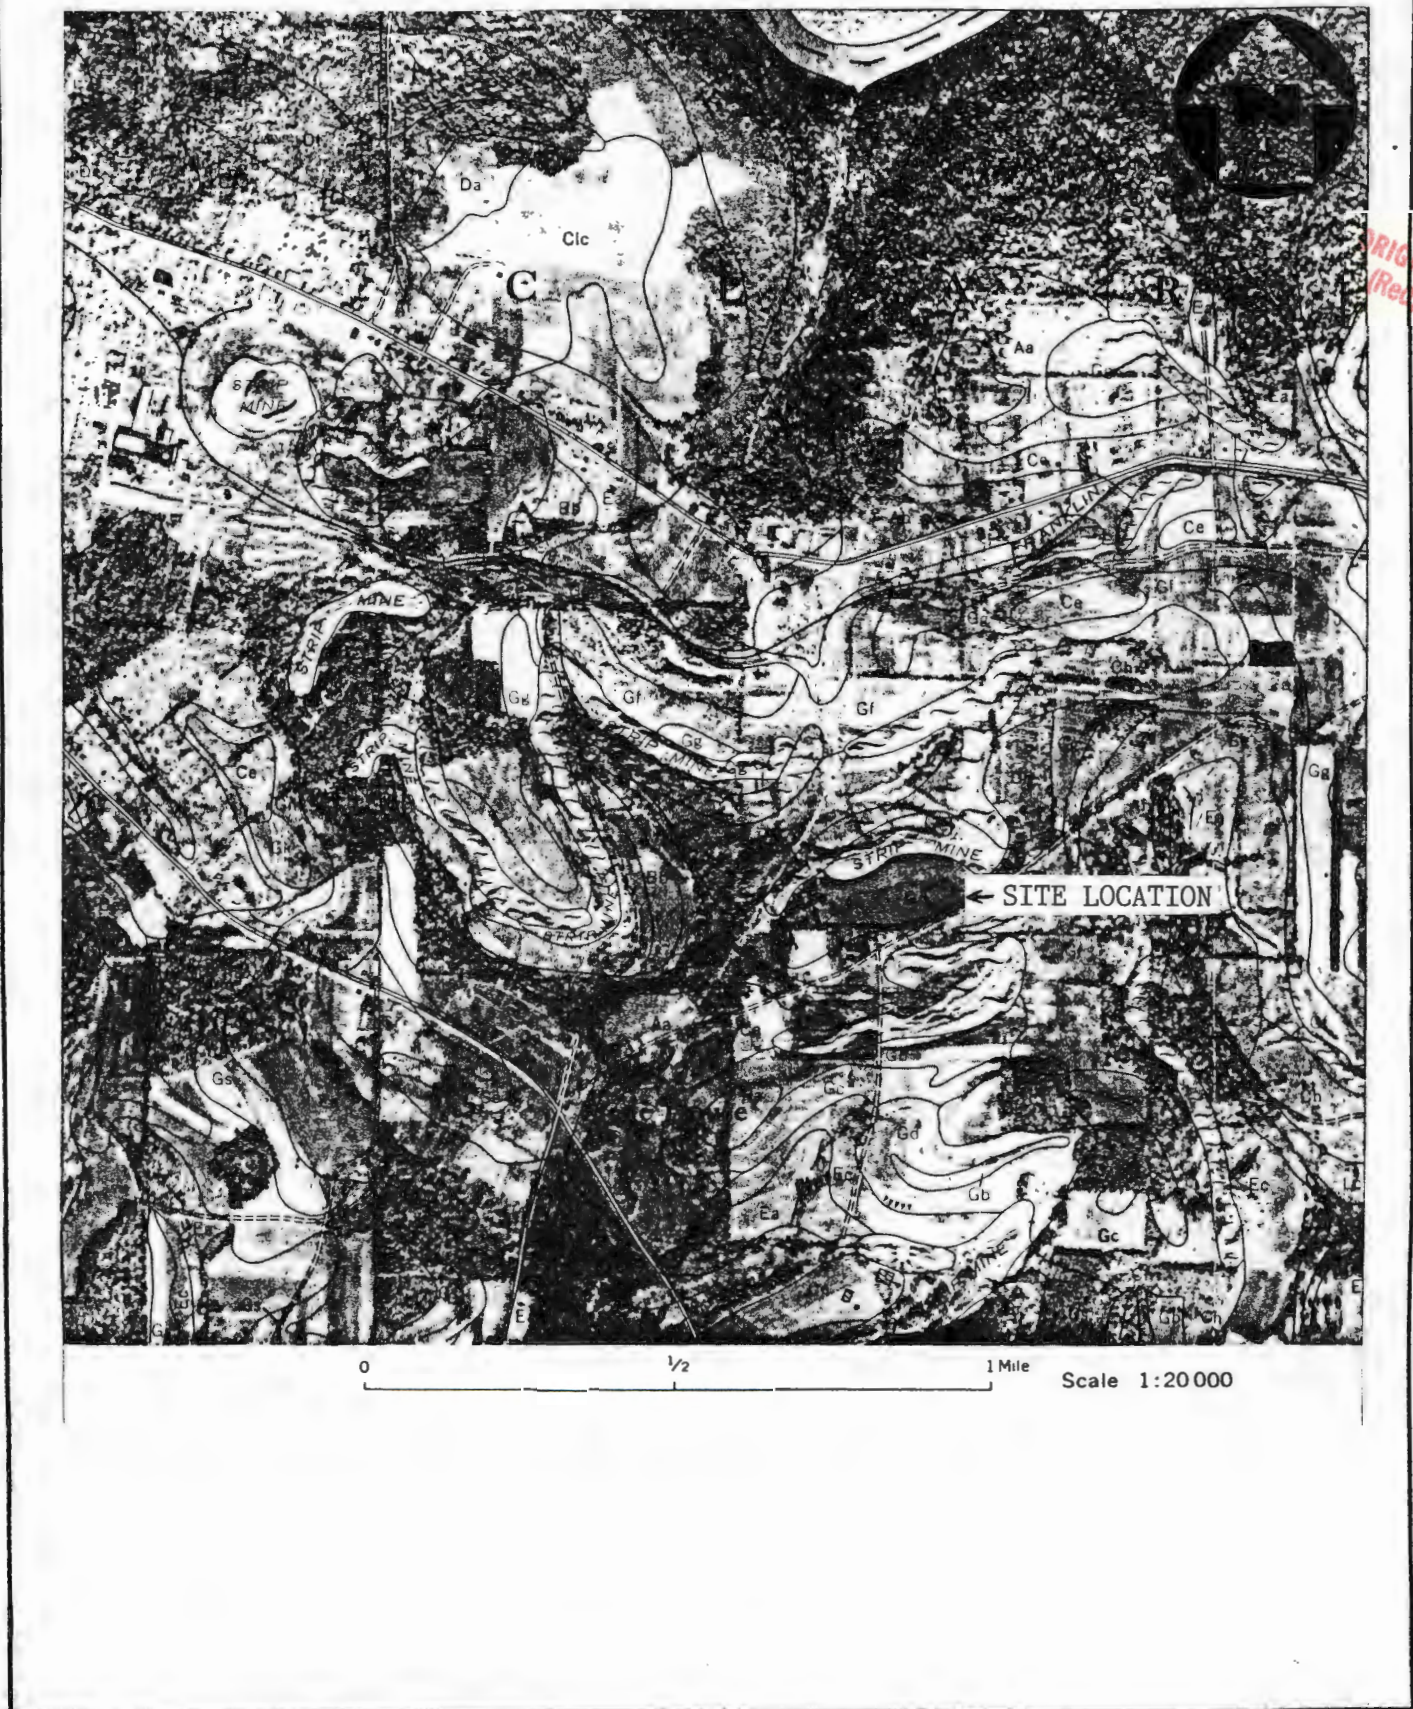
FIGURE 3.2

The site is mapped as being underlain by soils of the Gilpin Series (see figure 3.2, page 3-5). The Gilpin silt loam that underlies the site has a slope of 5 to 12 percent. This soil occupies moderate slopes on rounded hilltops and broad smooth ridges. Its water-supplying capacity is moderate to moderately low. Because of previous mining activity around the site and because of site-related activities, it is unlikely that the properties associated with these soils persist.

SOIL MAP  
SLOAN LANDFILL SITE
